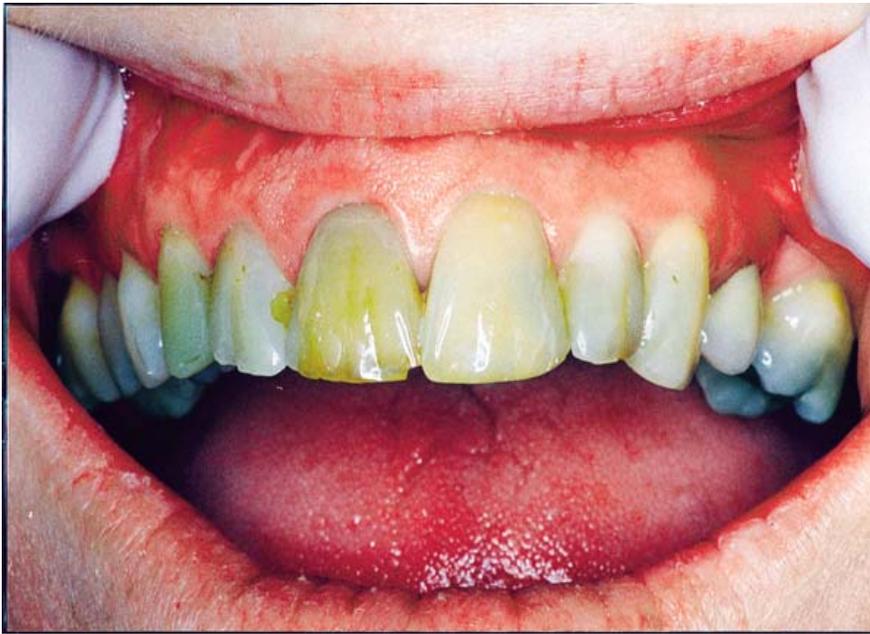
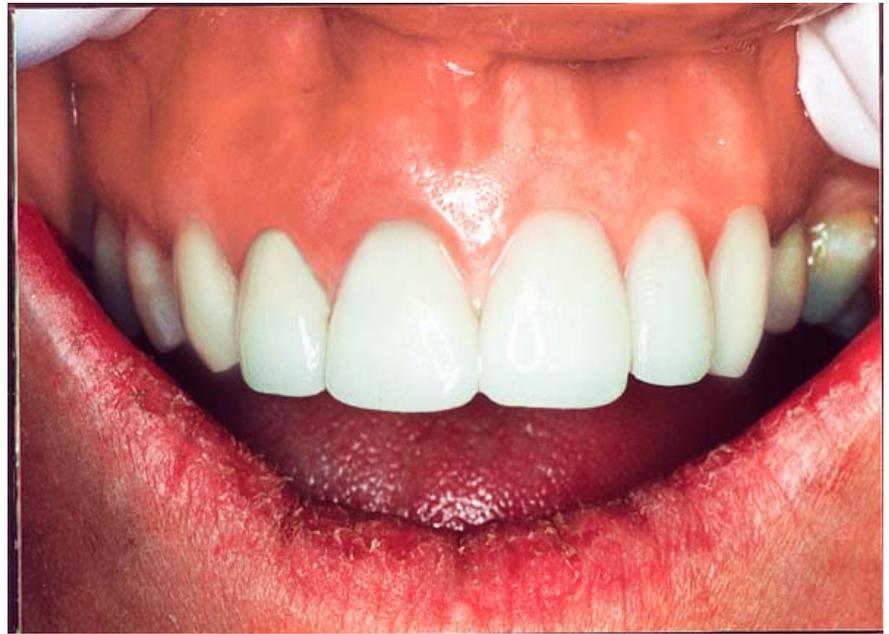
Diagnosis: M & D restorations with recurrent decay; discoloration due to previous endodontic treatment.

Treatment: All-porcelain crowns teeth # 6-11

Material: Vita® Mark II porcelain

Shade: A1 with Vita Akzent stain and glaze

- The challenge is being able to deliver an esthetic all-porcelain restoration in a single appointment. The strength and natural appearance of CEREC® restorations, coupled with the ability to provide them *now*, makes CEREC the *only* choice. -

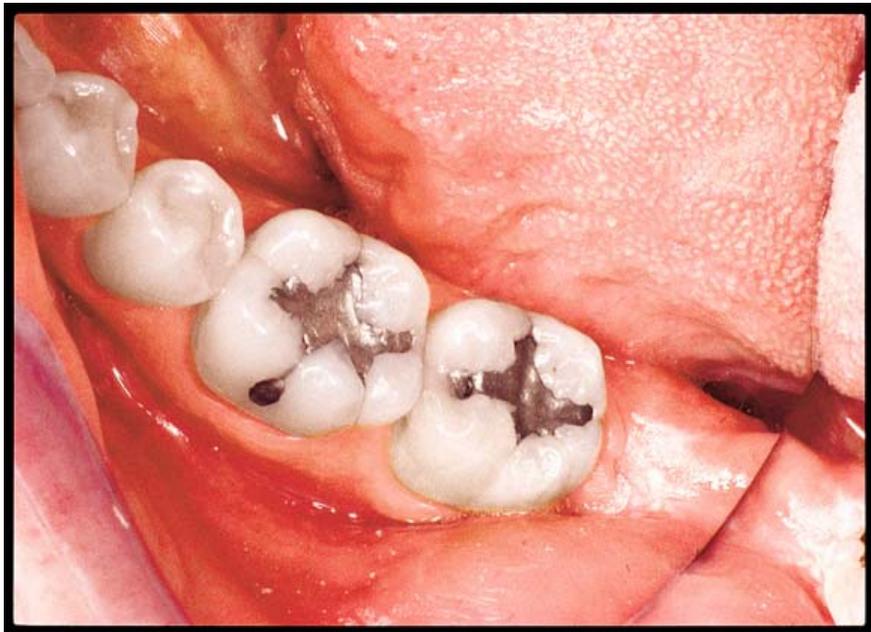
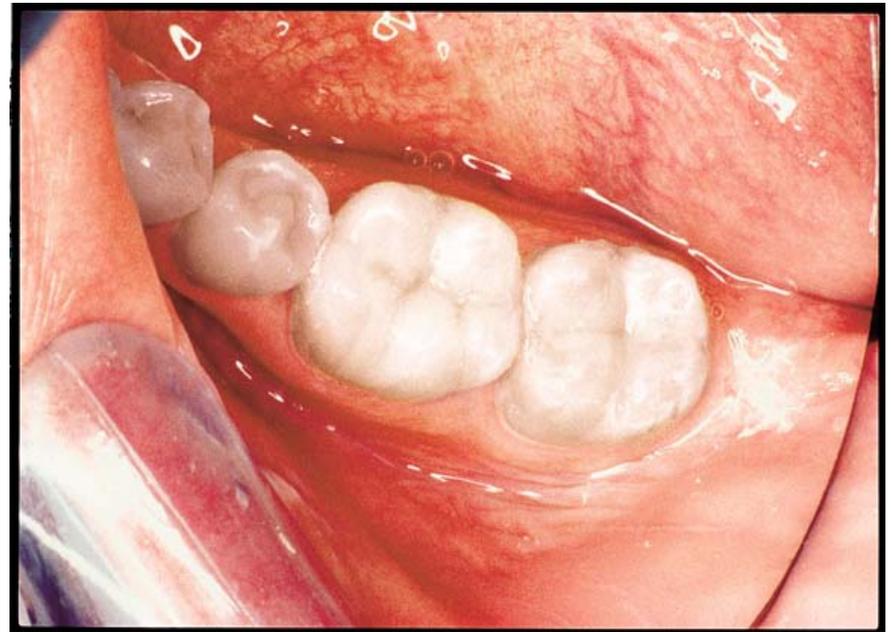
Diagnosis: Amalgam marginal failure,
external enamel stress fractures
30 & 31

- The old amalgams were breaking down and the extent of the damage to the natural tooth structure was becoming extensive as a result of recurrent caries undermining cusps.

Treatment: Excavation, preparation &
restoration with tooth-conserving
CEREC® inlay/onlay restorations

Material: Vitabloc®

Shade: A2

CEREC restorations were chosen instead of laboratory fabricated full coverage in order to maintain adaptability and biomechanical integrity during function. The “tooth-like” physical properties and highly etchable nature of the CEREC materials allowed for maximum bond strength and minimal tooth destruction during preparation. A beautiful final result was achieved in a time-conserving manner. -

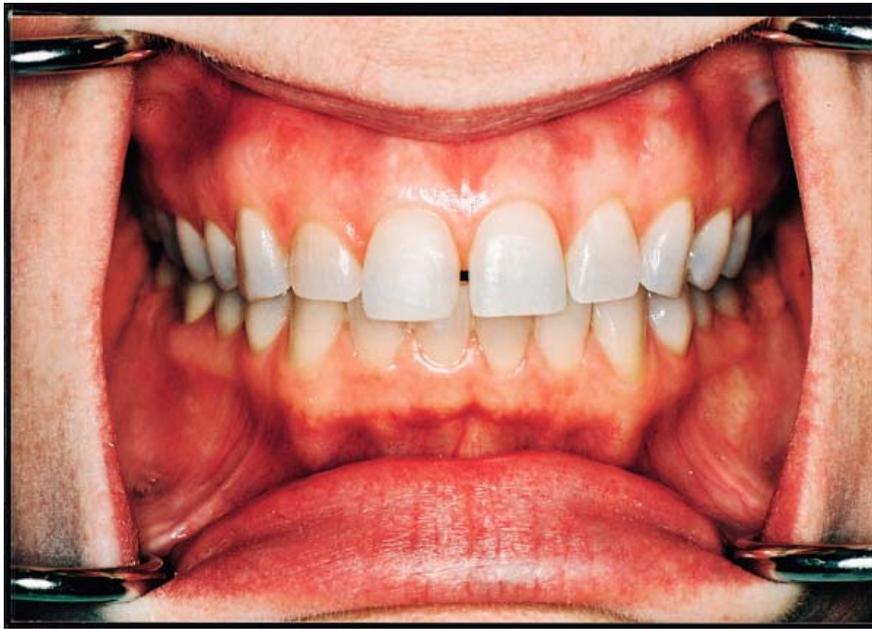
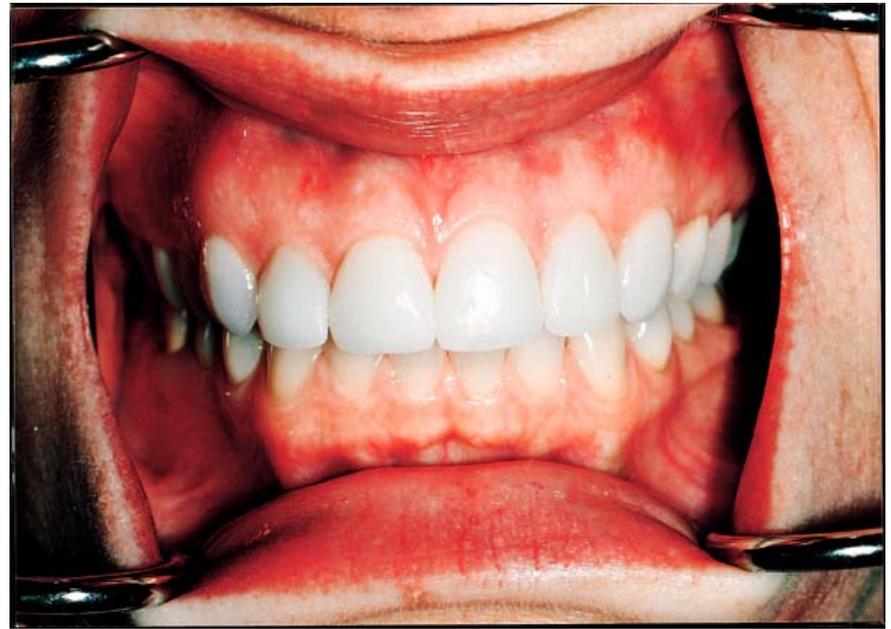
Diagnosis: Multiple diastemas of maxillary anterior teeth; fractured and chipped composite bonded restorations

- My patient presented with multiple diastemas of her maxillary anterior teeth. In the past, she had several composite bonded restorations that had continually fractured and chipped. Having over ten years experience with CEREC restorative materials, I felt extremely comfortable restoring her six anterior teeth with CEREC veneers. Prior to her restorative appointment, the patient had decided to whiten her teeth.

Treatment: Restore 6 anterior teeth with CEREC® veneers

Material: Pro-CAD®

Shade: 100

She requested very light veneers for the final restorations. I used Pro-CAD 100 blocks with custom satin and glaze. -

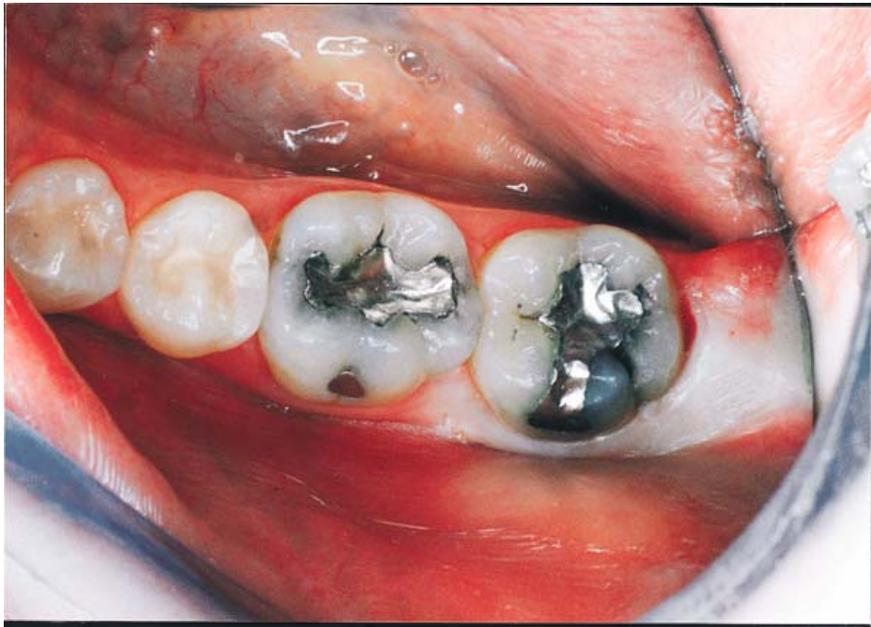
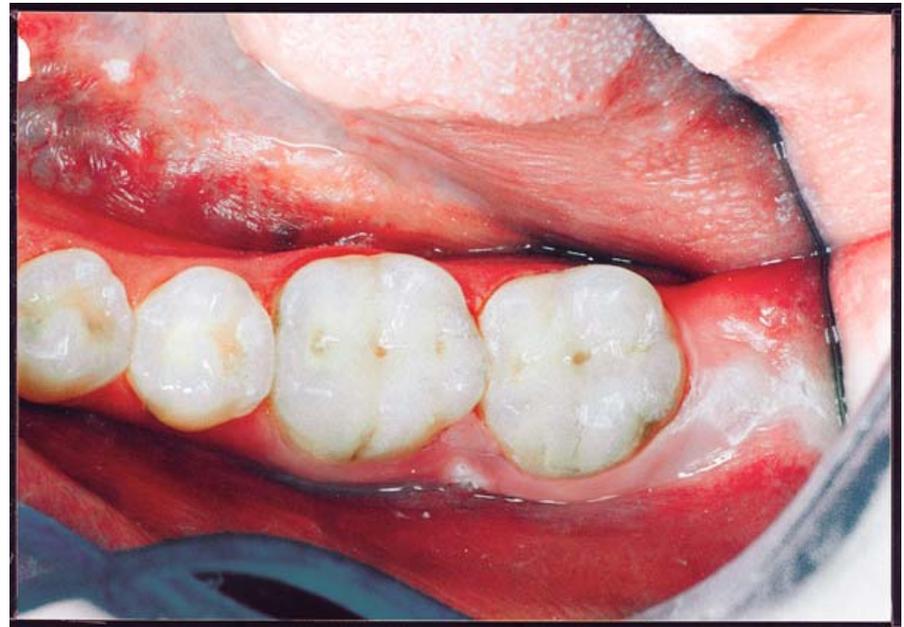
Diagnosis: Amalgam marginal failure &
radiographic recurrent caries
18 & 19

- The patient disliked her unsightly black amalgam restorations. She understood the nature of recurrent caries and the necessity to replace her amalgams to restore the teeth. Direct resin restorations were decided against due to the dimensional extent and resultant polymerization shrinkage that characterizes larger resin restorations. CEREC restorations were done to facilitate tooth-conserving methods while providing a long-lasting, natural-looking metal-free restoration. -

Treatment: Excavation, preparation &
restoration with conservative
CEREC® inlay restorations

Material: Pro-CAD®

Shade: 200

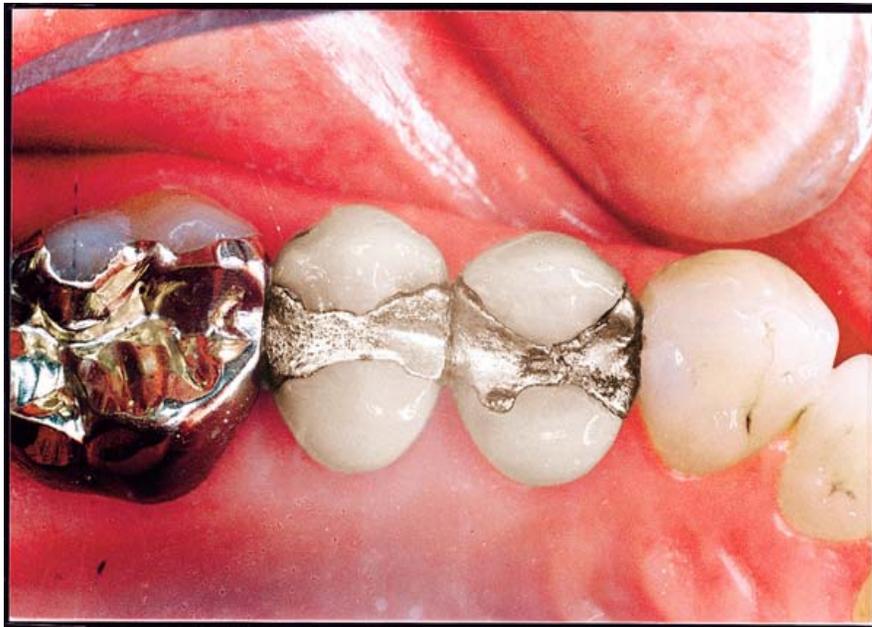
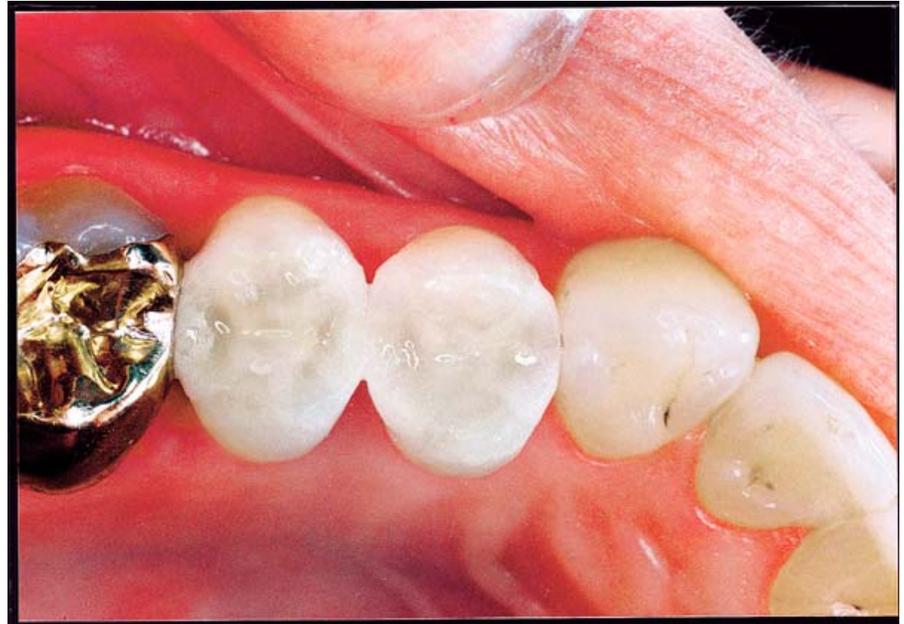
Diagnosis: # 12 fractured amalgam,
13 recurrent decay

Treatment: MOD CEREC®s

Material: Vita® porcelain bonded with
Optibond® FL and
Heliomolar®

Shade: A2

- Perfect CEREC case. Allows strengthening of teeth while preserving their natural appearance. With adjacent teeth, I prefer to prep and design one. Prep the second one while first milling. Try in the first, then image and design second. Can then bond first while milling second, or wait and bond both simultaneously. -

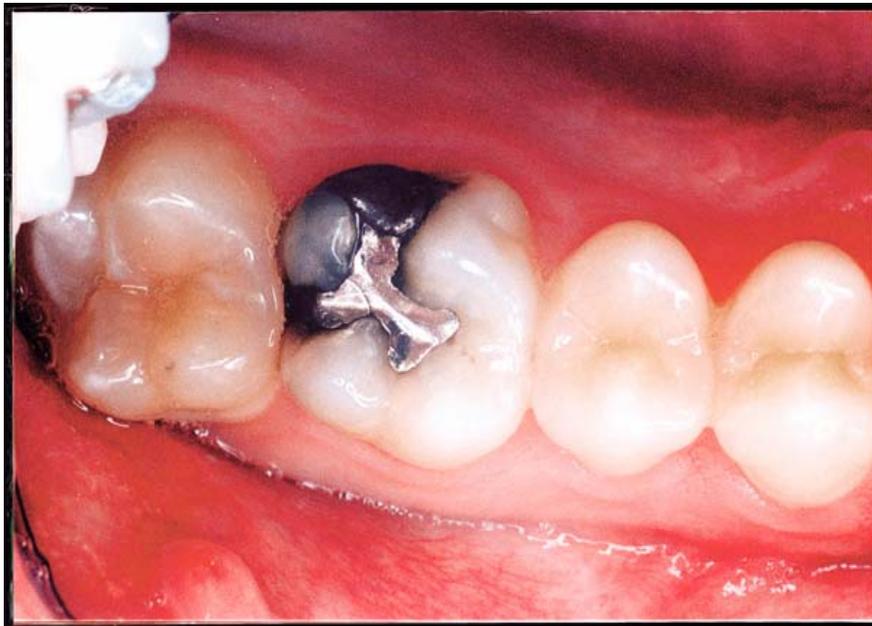
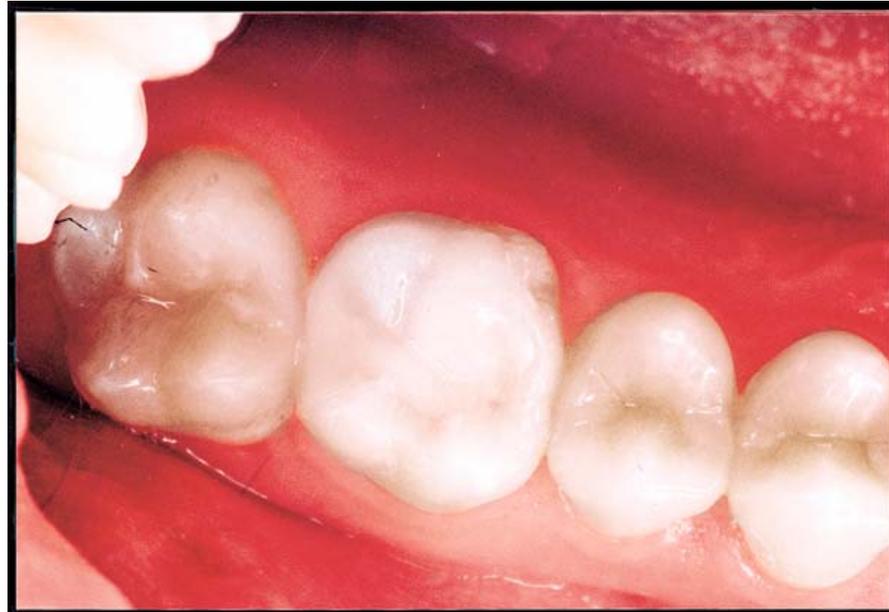
Diagnosis: Defective amalgam with recurrent decay

Treatment: DOL onlay

Material: Vita® Mark II porcelain bonded with Optibond® FL and Heliomolar®

Shade: A2

- Excellent case for correlation. Accurate model of preexisting occlusal morphology significantly simplifies onlay design. CEREC®'s ability to exactly duplicate the pretreatment model vastly reduces post-cementation occlusal adjustments. This restoration only required polishing. -

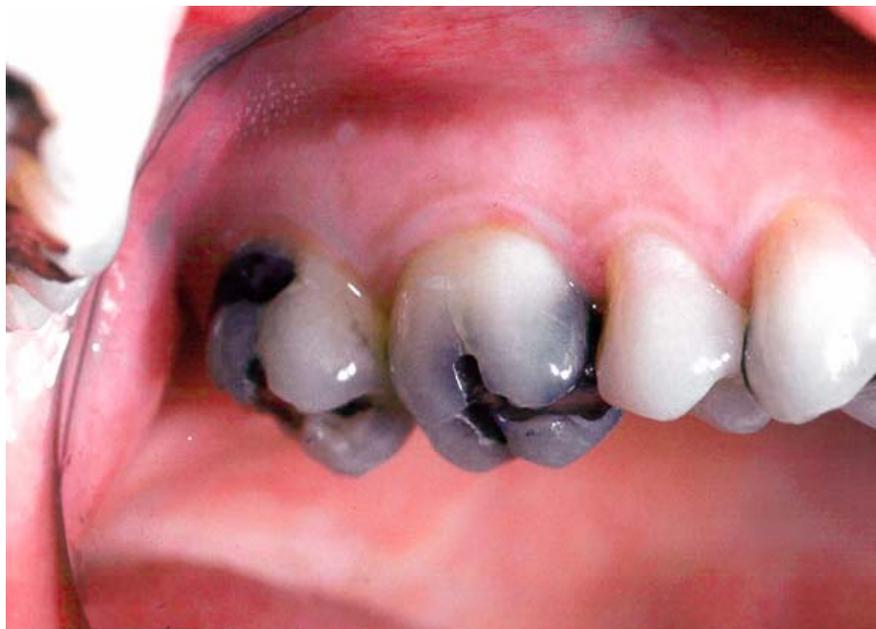
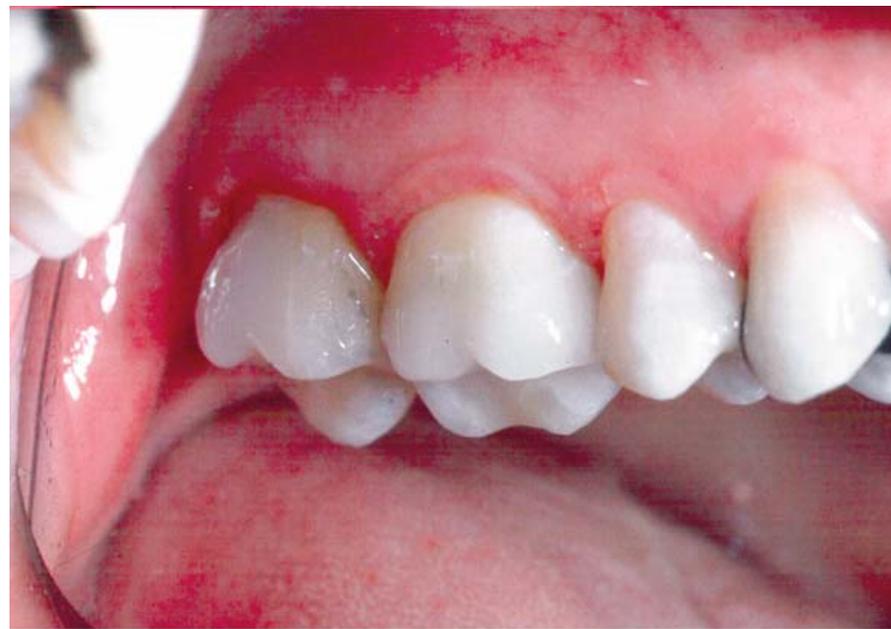
Diagnosis: Defective amalgam restorations with recurrent decay and buccal cusp fractures on both # 14 & # 15

- This patient presented with defective restorations that required replacement and cuspal coverage. The typical restorative solution would have been full coverage for both restorations. The teeth would require overpreparation to hold a temporary and minimal reduction for a ceramic onlay would leave little to hold the temporary as well. Placement of a conservative onlay in a single visit solves all of the associated problems and completes the treatment in a single visit of about 2.25 hours. -

Treatment: # 15 DOBL Onlay & # 14 MODB Onlay

Material: Vita® Mark II

Shade: VitaPan Master 3D shade 1M2C

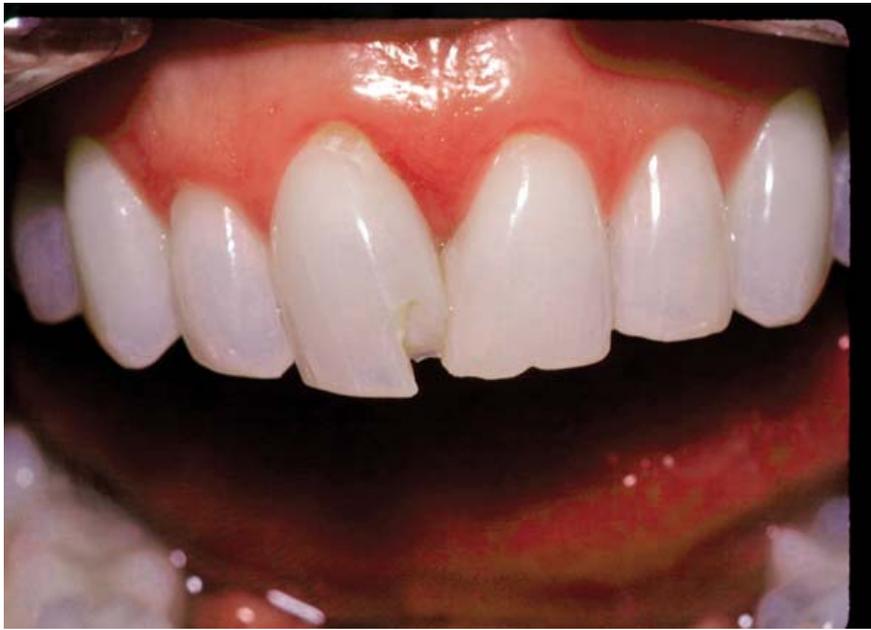
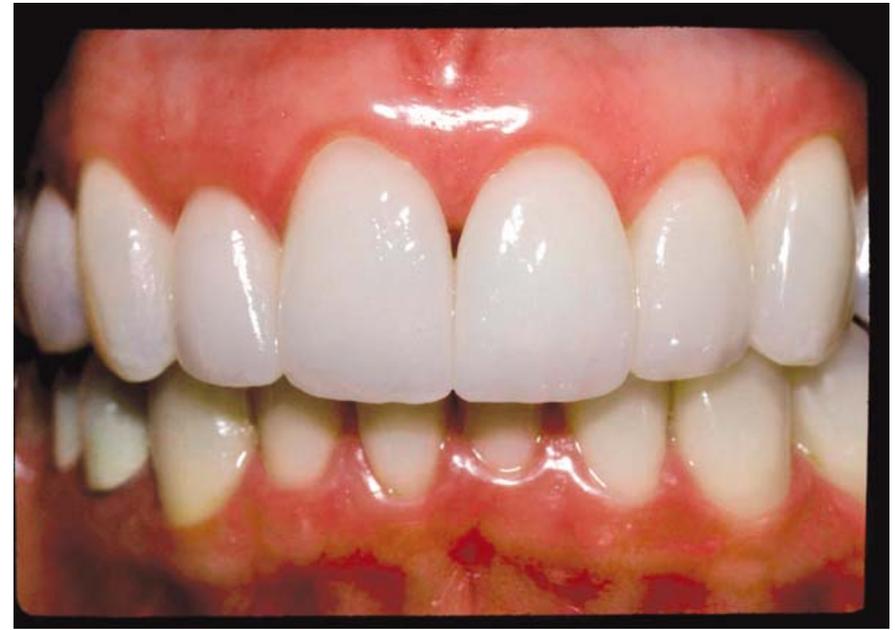
Diagnosis: Lost filling and fractured incisal edge # 8, altered tissue level or overlapping of incisors

- This patient presented with a lost MI resin on # 8, which had been discolored as well. This provided the impetus to restore the tooth and consider a cosmetic makeover. Tissue recontouring was required to align the gingival zenith of # 7. Characterization was accomplished through cutting back and layering incisal porcelains to create the translucent effect. Incisal length was increased and axial inclination was corrected. -

Treatment: Veneers # 7-10 and laser gingivectomy # 7

Material: Vita® Mark II

Shade: VitaPan Master 3D shade 1M1C
